Mystery Solved? The CD 128 Hemingray CSO

MYSTERY SOLVED? THE CD 128 CSO

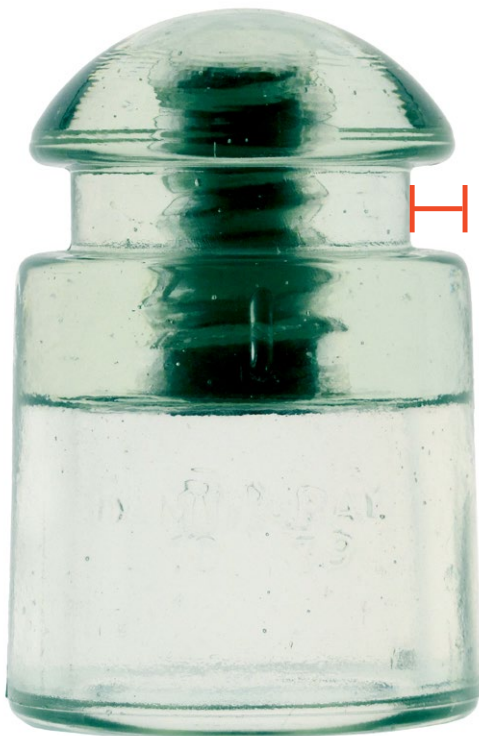
FRONT VIEW OF [080]:
WIRE GROOVE APPEARS SHALLOW;
VERTICAL BARS ON FRONT & REAR

wire groove with digital calipers—the widest part of the "O" measures 1/4" thicker (1.9" average) than the narrow part of the "O" (1.65" average). By comparison, a CD 128 CSA or CSC has a uniform 1.62" wide wire groove all the way around. Suddenly, the vertical bars embossed right below the wire groove made sense: their placement indicates the midpoint of the wire groove's narrow sides. Given this, my theory is that "CSO" stands for "Carrier circuit, Steel pin, Oval wire groove".

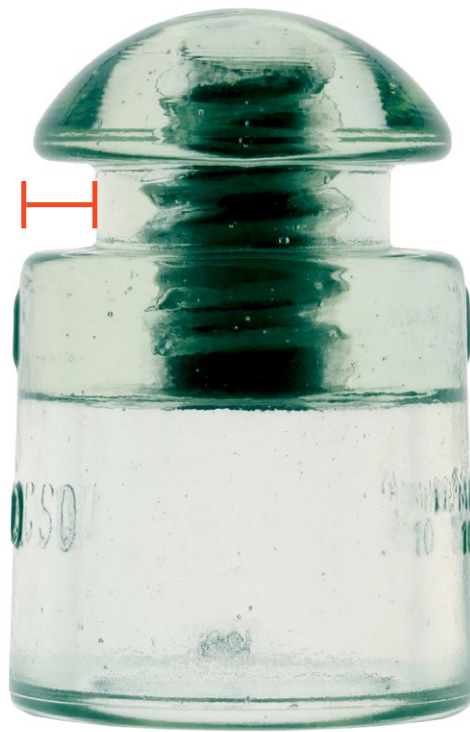
SIDE VIEW OF [080]:
WIRE GROOVE APPEARS DEEPER;
NOTE VERTICAL BAR ALIGNMENT

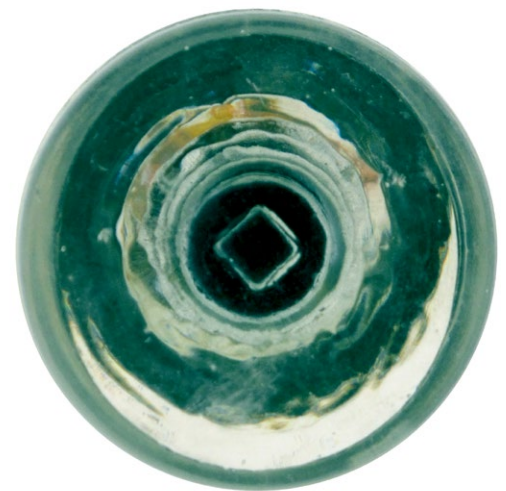
TOP VIEW OF [075]:
THE DOME CURVATURE AFFECTS THE
VIEW, BUT YOU CAN STILL SEE THE OVAL!

Recently, as I was photographing a few new ones I had just purchased, I noticed that the wire groove "thickness" changed as I turned the insulator sideways! Intrigued, I pulled out my other CSO pieces and, sure enough, they all had *oval shaped wire grooves*. I measured the

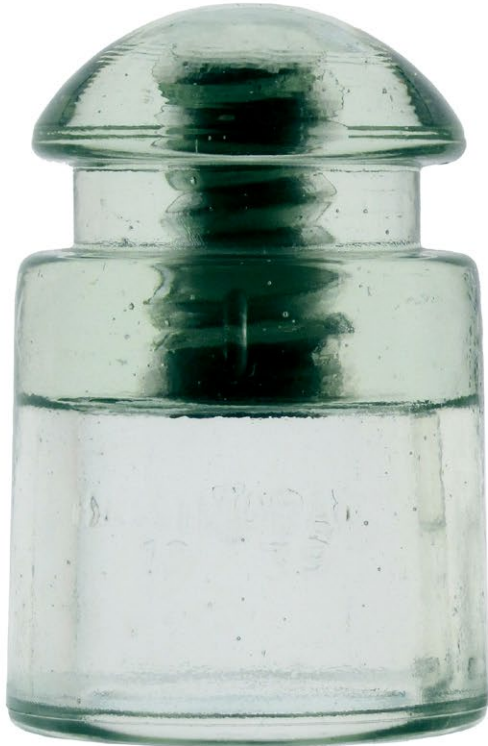
HEMINGRAY CD 128 [080] FRONT
10_39 (1939 MANUFACTURE)
LEAD INSERT IN THE THREADS
NO RIDGE INSIDE THE SKIRT

- Larger embossing in middle of skirt (what I call the "Large Style, Alternate 3" embossing; see: <https://www.hemingray.info/database/embossingstyles.php>)
- [080] embossing: "O" is engraved over an "A"; no periods between the letters "CSO"
- Most have a lead insert in the threads
- Some specimens have a ridge inside skirt

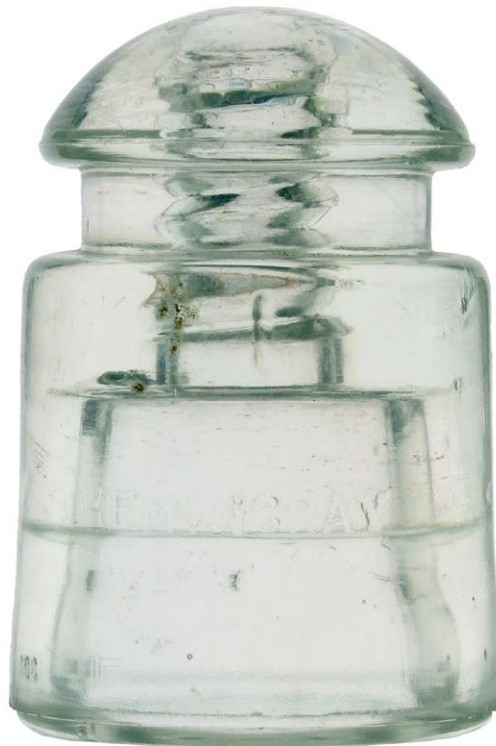
HEMINGRAY CD 128 [080] FRONT
7_39. (1940 MANUFACTURE)
NO LEAD INSERT (POSSIBLY REMOVED)
HAS A RIDGE INSIDE THE SKIRT

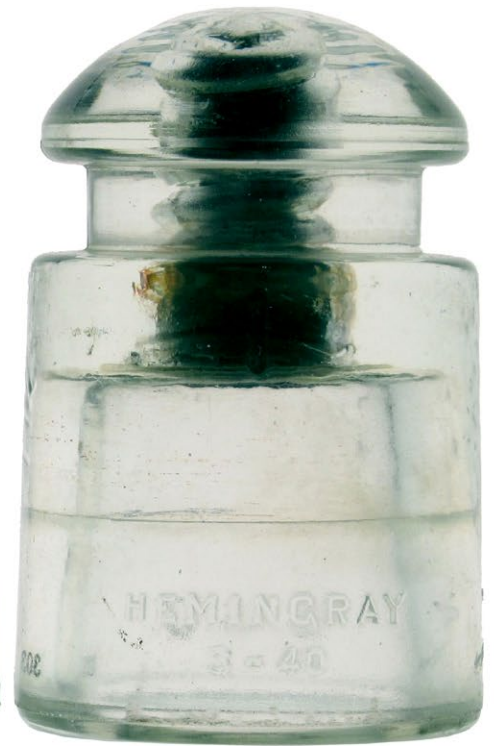
HEMINGRAY CD 128 [075] FRONT
3-40 (1940 MANUFACTURE)
BRASS BUSHING EMBEDDED IN THREADS
HAS A RIDGE INSIDE THE SKIRT

- Smaller embossing, lower down on skirt
- [075] embossing: no "A" over-engraved; periods between the letters "C.S.O."
- A brass bushing is embedded in the threads with a square in the top.
- All specimens have a ridge inside the skirt

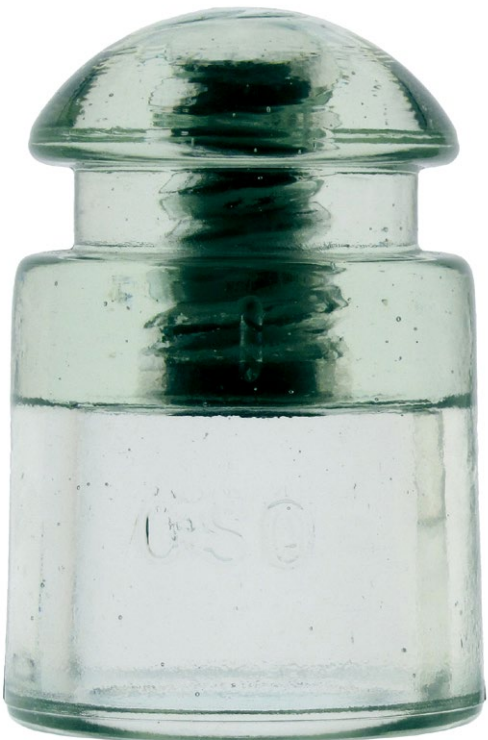
HEMINGRAY CD 128 [080] REAR
"O" OVER "A"; NO PERIODS IN CSO

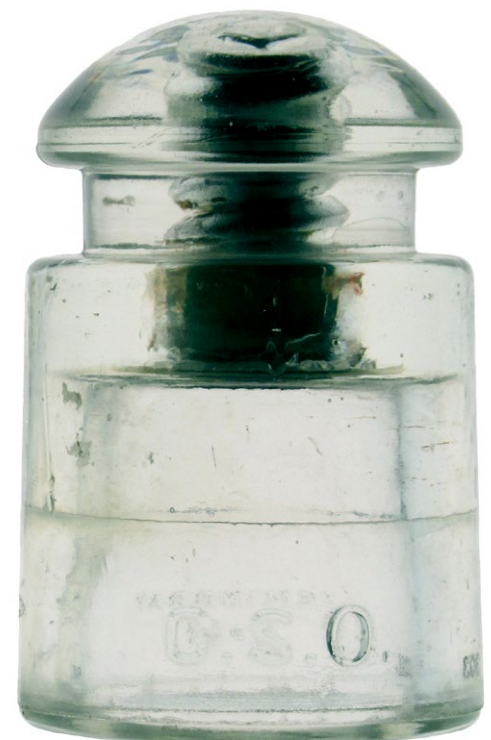
HEMINGRAY CD 128 [075] REAR
PERIODS IN C.S.O.; EMBOSSING LOWER DOWN
